PCB CHANGE ATRLM080 to ATRLM088

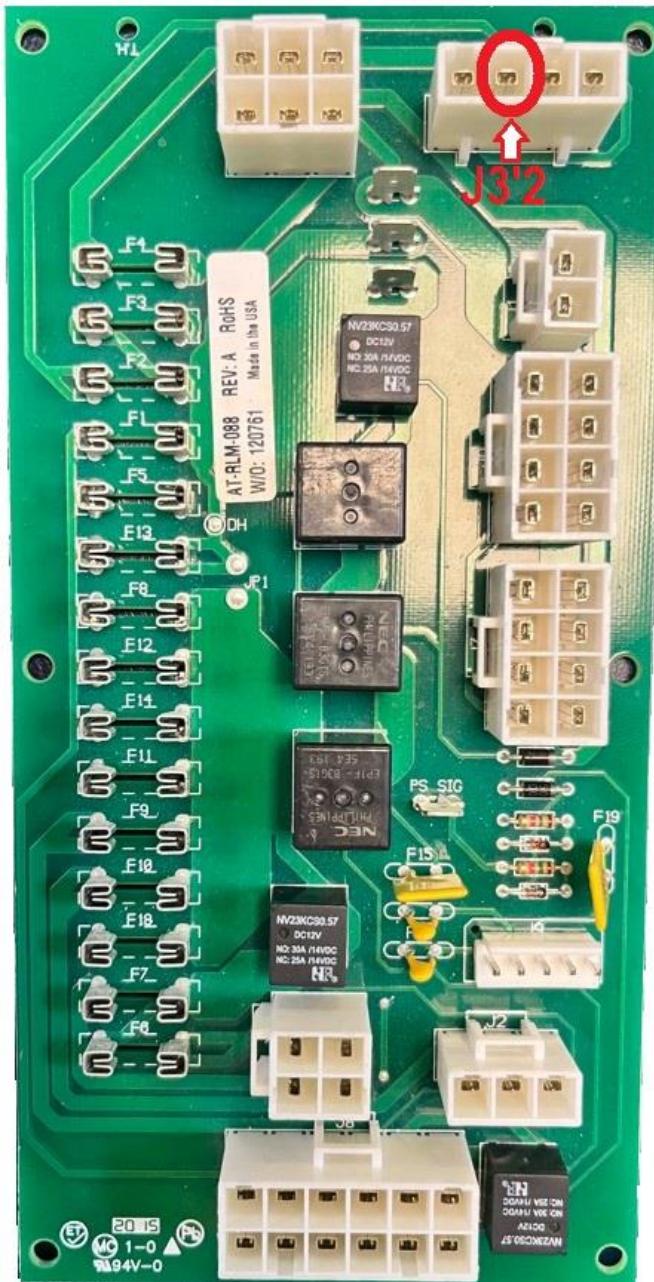
- 1) if the vehicle has a Truma Combi or an Alde system then no modifications are required.
- 2) Double check this by checking the plugging on the harness, if pin J3'2 is unpopulated (see fig 1) then no modifications is required.

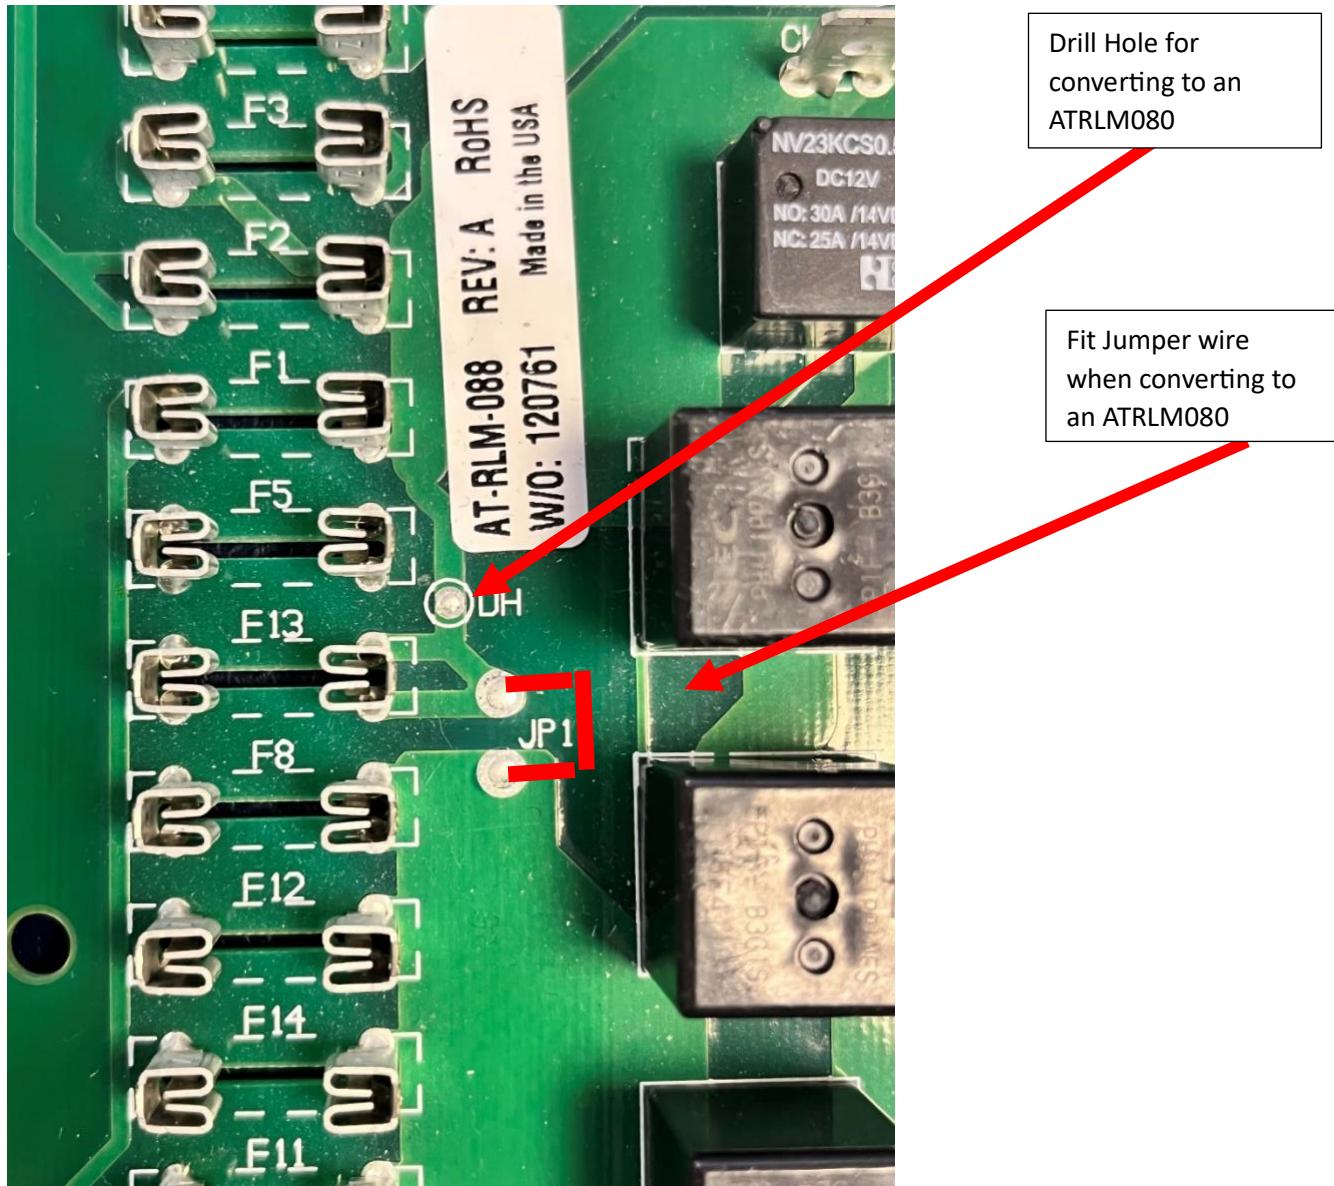
If a whale system is installed and pin J3'2 is populated, then modifications to the PCB is required (see fig 2)

If this modification needs to be done this can be done at BCA.
